MERRIMACK RIVER BASIN
WILTON, NEW HAMPSHIRE

SOUHEGAN RIVER WATERSHED
DAM NO. 33
NH 00265
NHWRB 254.34

PHASE I INSPECTION REPORT
NATIONAL DAM INSPECTION PROGRAM

AUGUST 1979

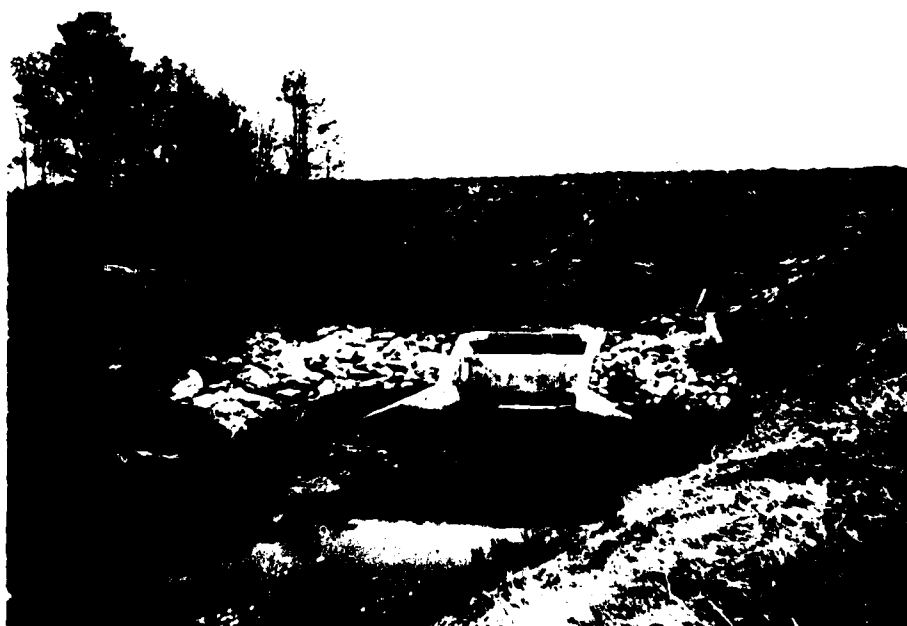
Overview photo of downstream slope

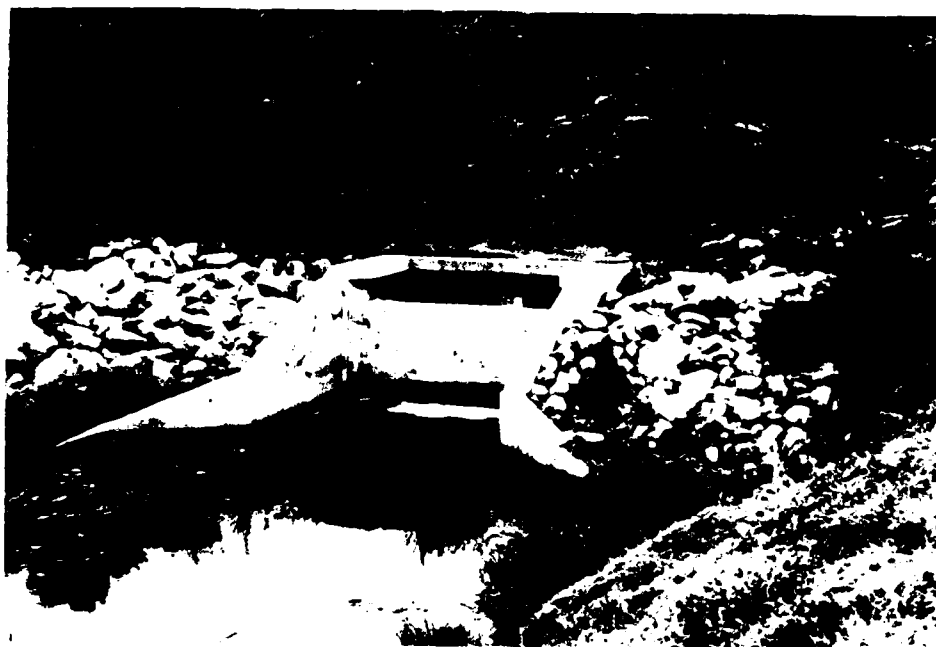
This structure is generally in good condition. There is some efflorescence on both ends of the top surface of the baffle wall and some minor erosion and staining of the headwall. There is no safety fence around this structure.

6. View of impact basin
